**SIMPOSIUM ON “SITING OF NEW NUCLEAR
POWER PLANTS AND IRRADIATED FUEL
FACILITIES”**

***“THE SEISMOTECTONIC
ENVIRONMENT OF FUKUSHIMA
ACCIDENT-LESSONS LEARNED”***

Antonio R. GODOY

FUKUSHIMA DAIICHI NPP (F1)

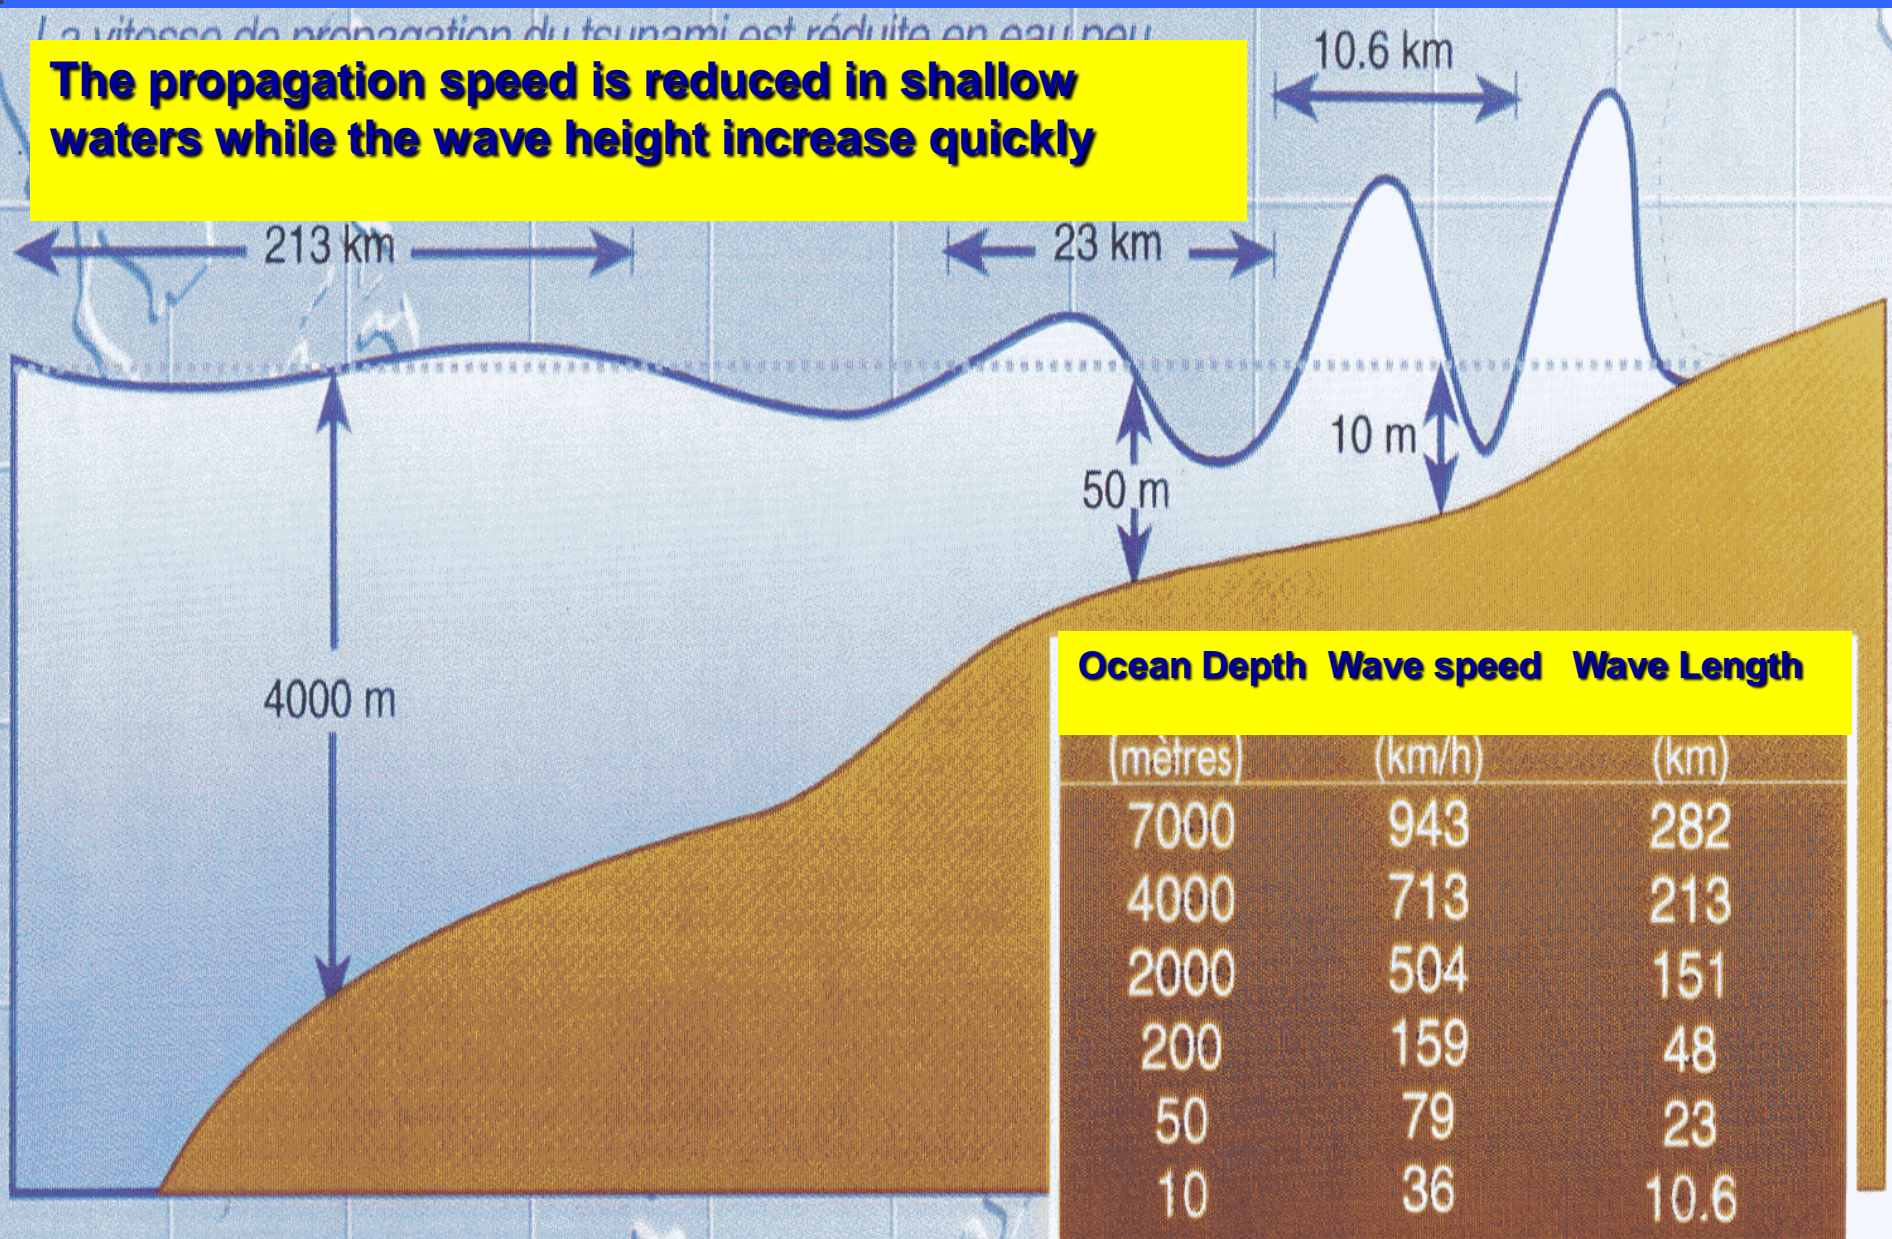
The propagation speed is reduced in shallow waters while the wave height increase quickly

Ocean Depth	Wave speed	Wave Length
(mètres)	(km/h)	(km)
7000	943	282
4000	713	213
2000	504	151
200	159	48
50	79	23
10	36	10.6

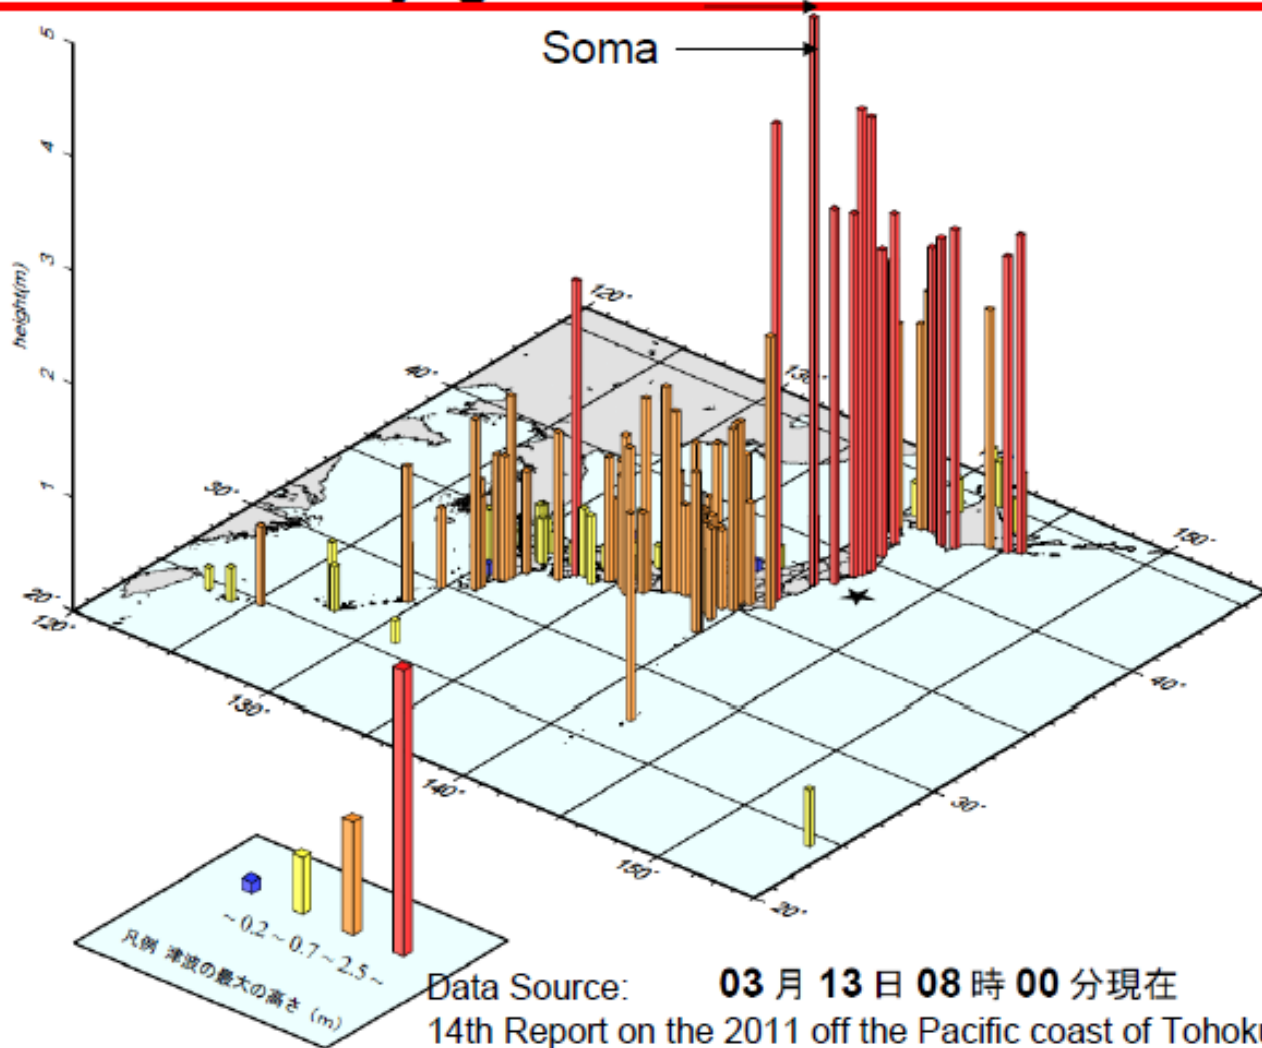
Height of Tsunami

High tsunami wave arrived on the coasts of Miyagi and Fukushima

Data Source: 03月13日08時00分現在
14th Report on the 2011 off the Pacific coast of Tohoku Earthquake by
Japan Meteorological Agency (Mar. 13 2011)

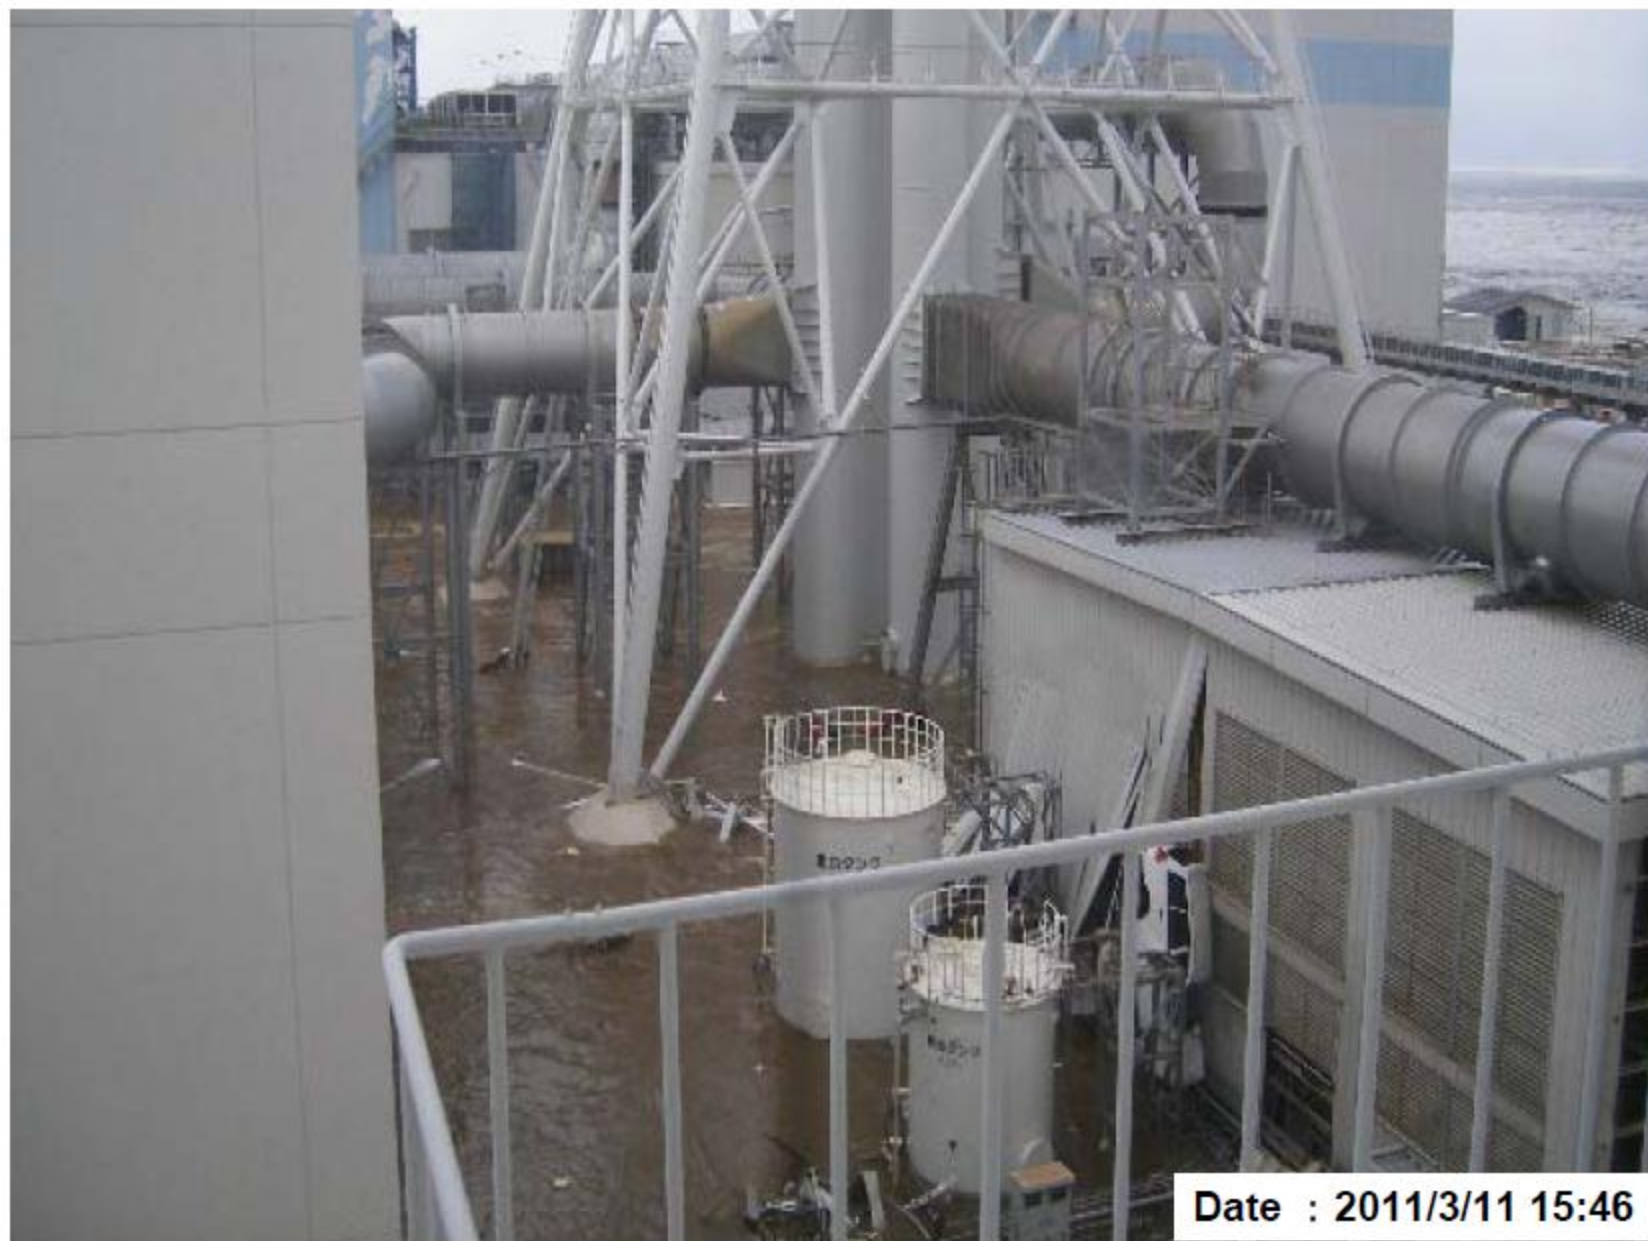
Date : 2011/3/11 15:46

Tsunami Attack to Fukushima Daiichi NPS

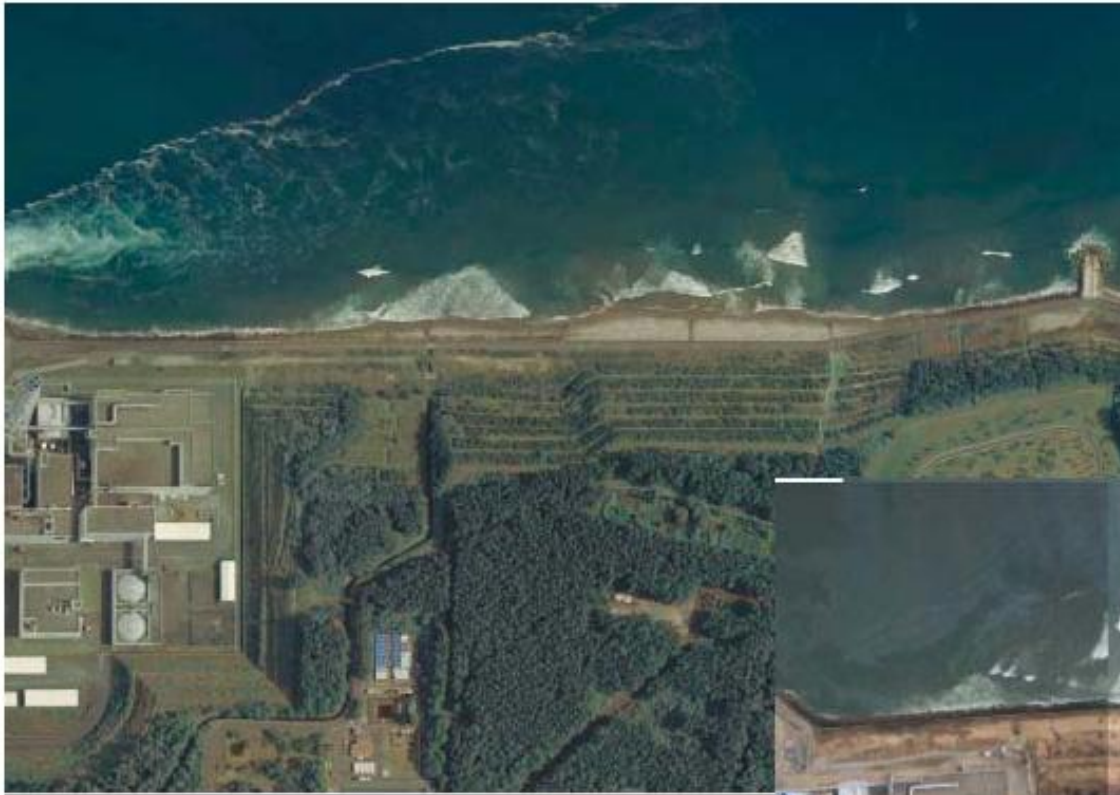
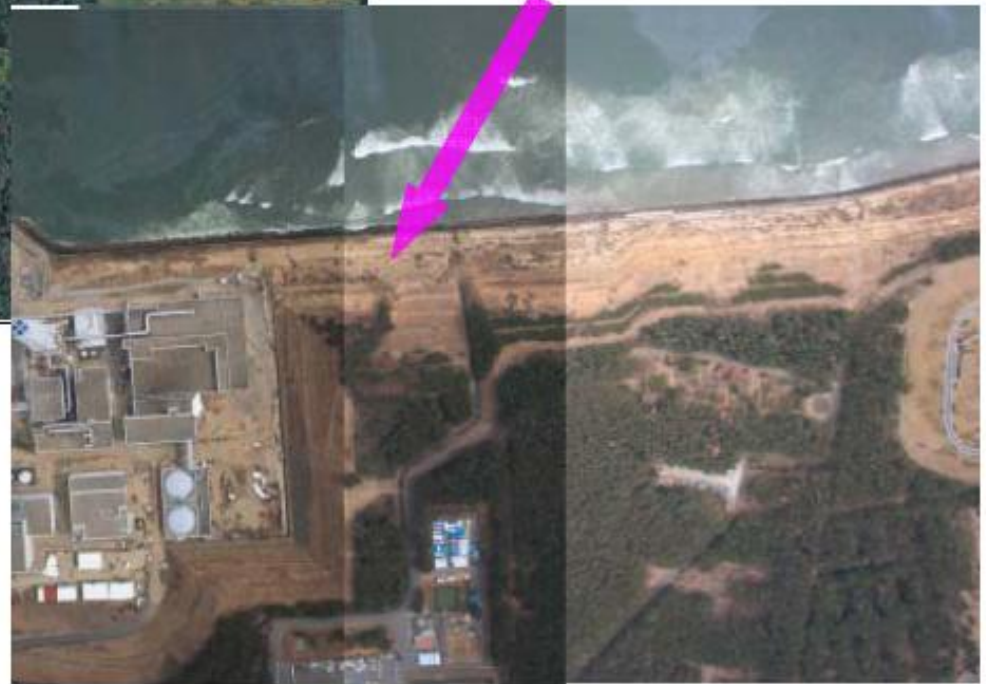
Pictures before / after Tsunami

Trees were stripped
away

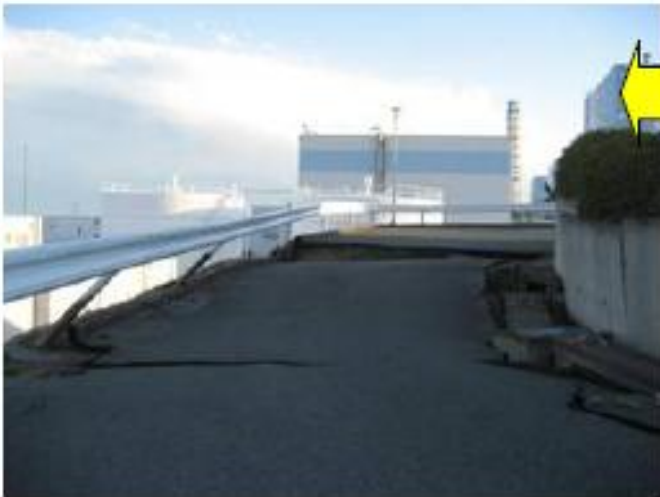
- During the initial response, there were several aftershocks, and work was conducted in extremely poor conditions, with uncovered manholes and cracks and depressions in the ground (in particular, nighttime work was conducted in the dark).
- There were also many obstacles blocking access routes.

Depressions in roads, etc.
Areas that were dangerous even to walk. Particularly dangerous at night.

Obstacles on access routes
Fire hoses, etc., were laid around access routes. After the explosion, rubble and damaged fire trucks became additional obstacles.

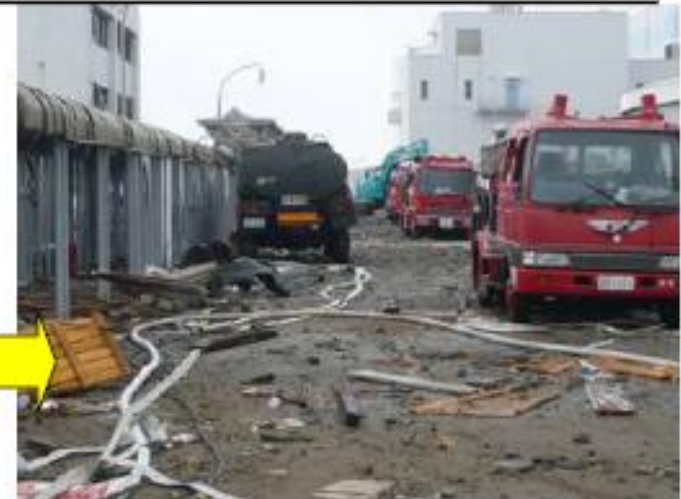
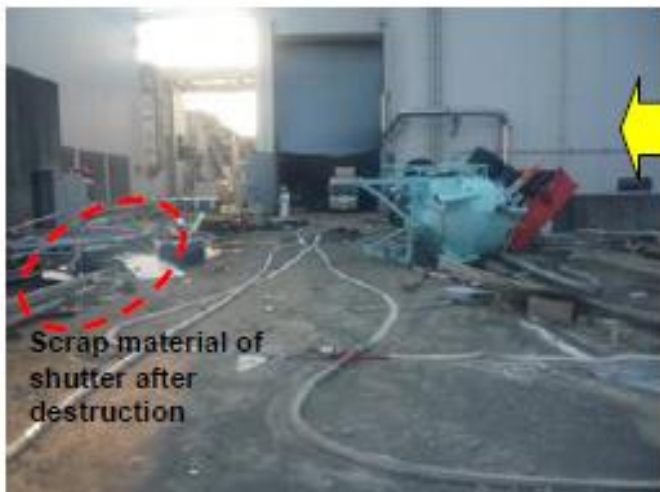
Scrap material of shutter after destruction

In order to enter the building, the large object delivery entrance was destroyed using heavy equipment.

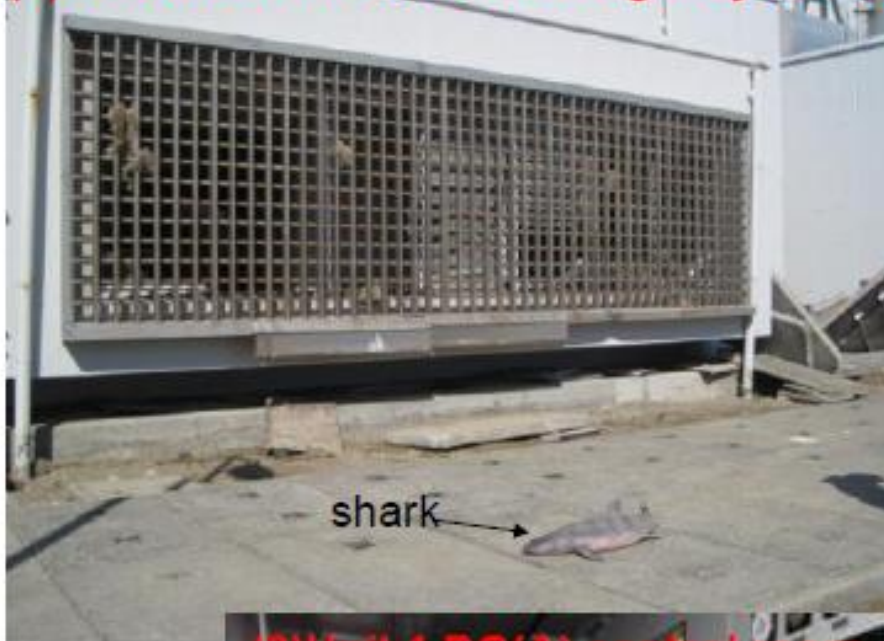
(1) Outside of the Unit 1 emergency fan room

Flooding of the Fukushima Daini Unit 1 Annex Area from the intake louver

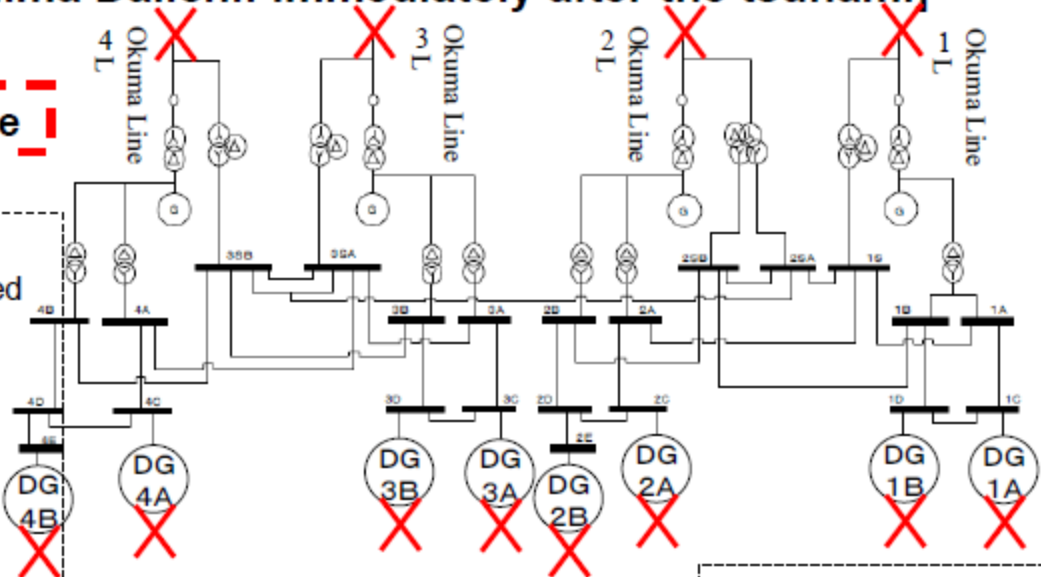
[Power supply at Fukushima Daiichi: Immediately after the tsunami]

No surviving power source

Receiving circuit breaker damaged in earthquake

Cause of shutdown is currently being investigated

The DG × signifies loss of function due to either "M/C failure," "loss of sea water system," or "DG main unit failure."

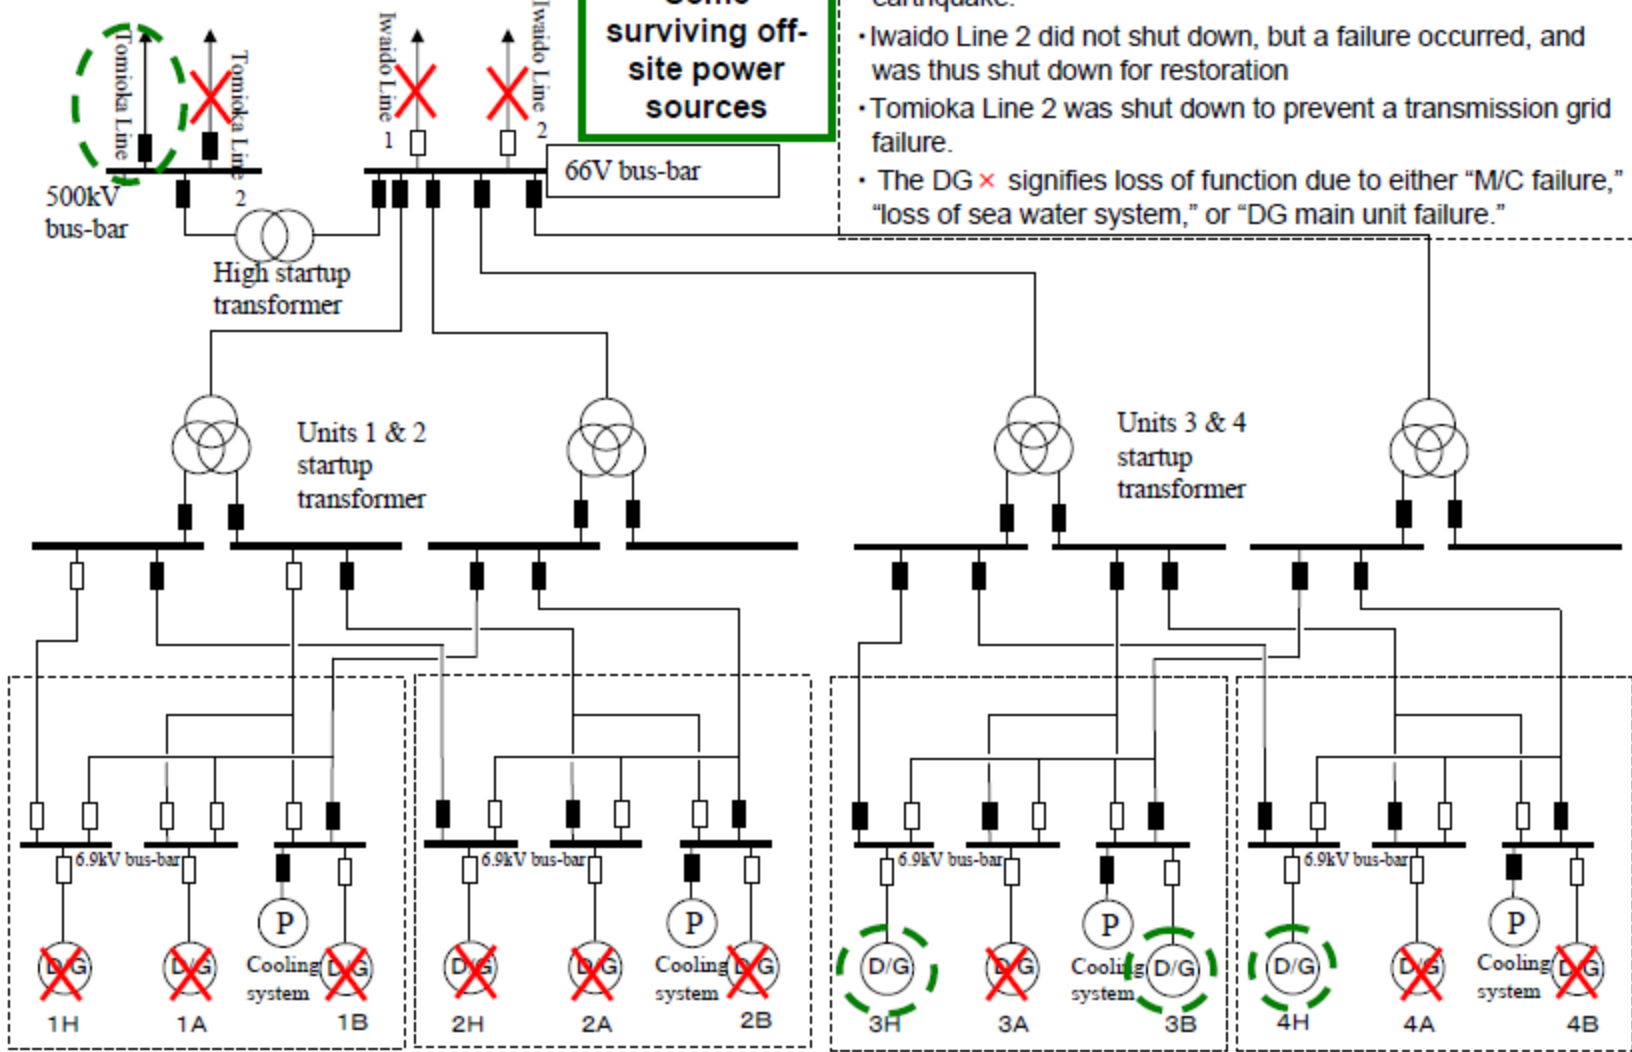
Some surviving off-site power sources

- Inspection of the Iwaido Line 1 was in progress from before the earthquake.
- Iwaido Line 2 did not shut down, but a failure occurred, and was thus shut down for restoration
- Tomioka Line 2 was shut down to prevent a transmission grid failure.
- The DG × signifies loss of function due to either "M/C failure," "loss of sea water system," or "DG main unit failure."

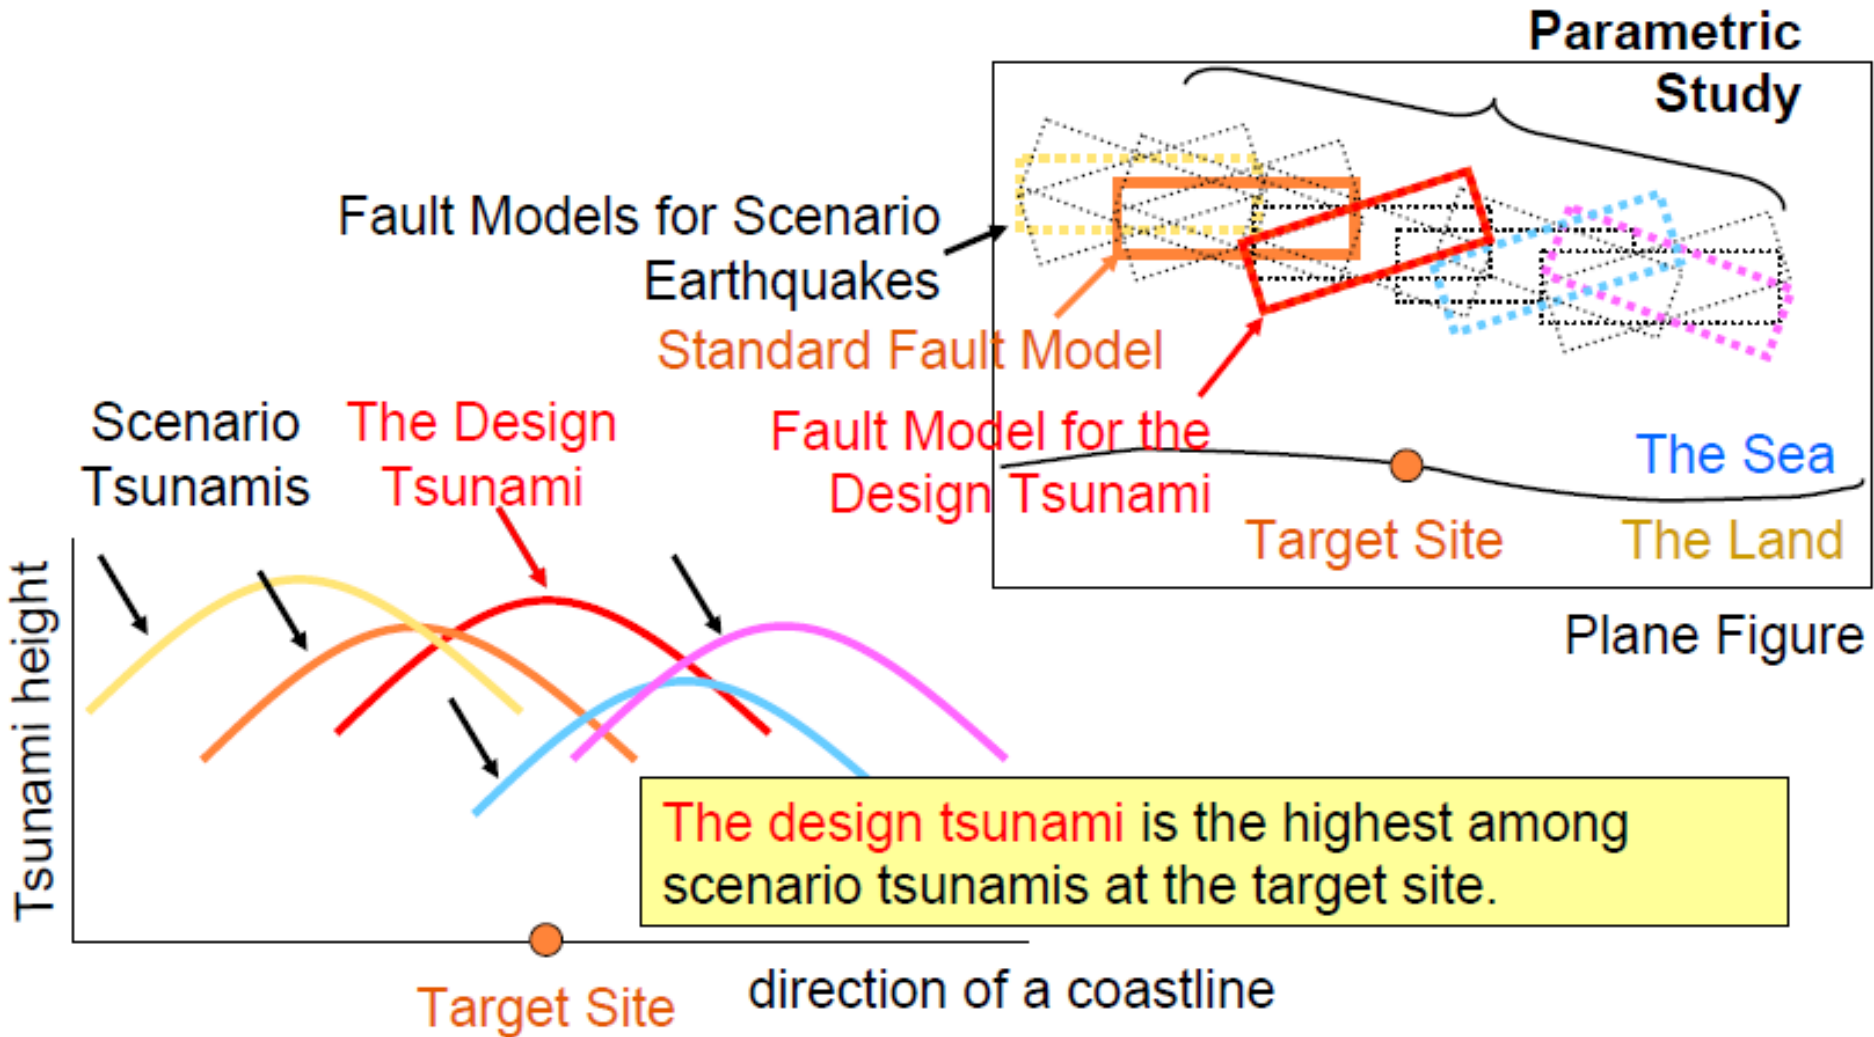
Parametric Study of Tsunami Source

JSCE document indicates explicitly the seismogenic source areas to be adopted for the THA
